Applies to: All Strength

VERIFIED PROBLEM AREA

Red Knobs Falling Off of Pull Pins on Strength

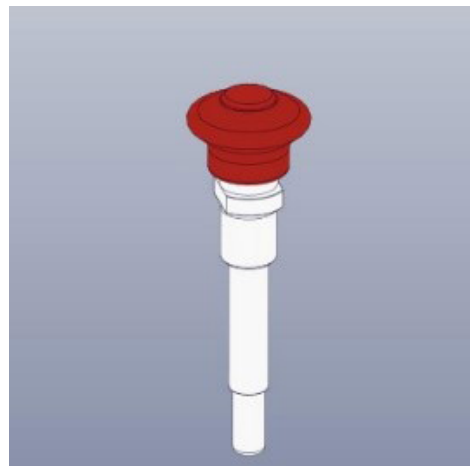
Fig. 1

Our investigation determined the male to female threads would become loose over time from the shock load of the spring rebound.

Our engineering team changed the design of the Pull Pin Knob which now incorporates a new fastening feature. The new Pull Pin Knob is secured by a lock nut threaded directly on to the pin shaft itself. Now the knob is completely held captive to prevent it from ever coming off. We have placed a cap above the locknut to make the new version easily identifiable to any customer or user. This is 100% backwards compatible across all applications, making it easy to upgrade ROM pins on an entire machine and/or in an entire club.
